Evaluating Oil Well Casing Corrosion Using Well Head Current Measurements

Ted Doniguian
Farwest Corrosion Control Company
1480 W. Artesia Boulevard
Gardena, California, U.S.A.
Fax: 310 532 3934
E-mail: fwcc@farwest.com

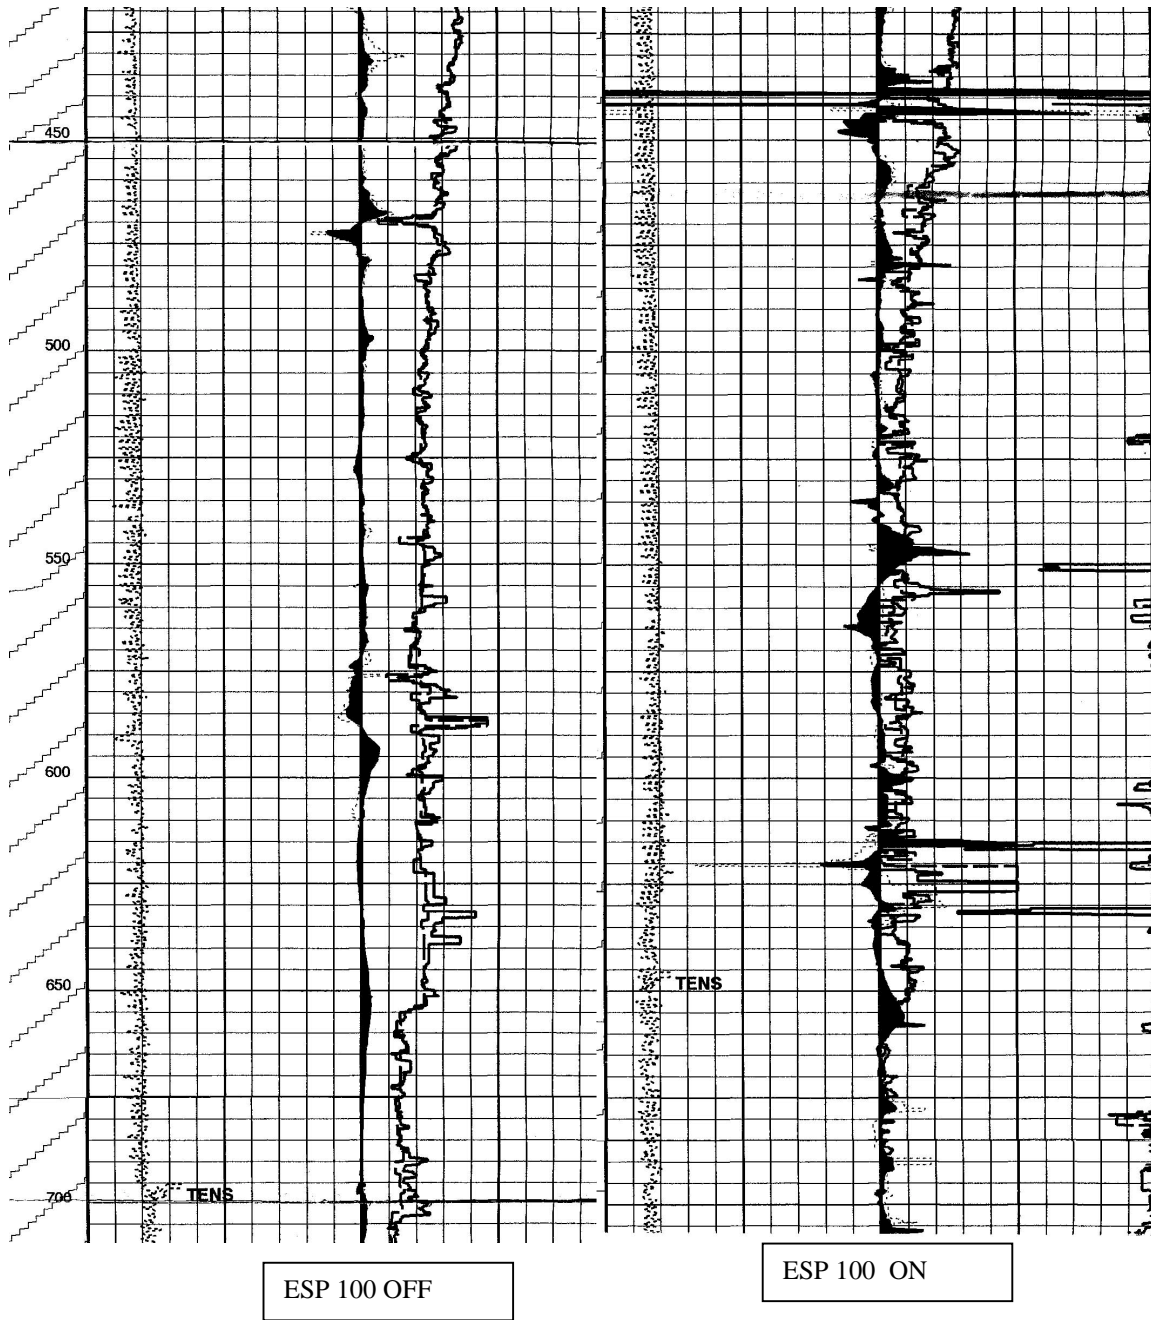
FIGURE 1

Corrosion logging is an accepted method for determining the integrity of oil well casings. During a previous investigation, corrosion logs indicated that severe corrosion was occurring on a significant number of oil well casings, located in the Arabian Gulf. The logs also indicated that the corrosion, occurring on the well casings being logged, increased substantially (Figure 1) when some ESP motors, located inside adjacent well casings, were activated.

CASING 015 – CORROSION LOG

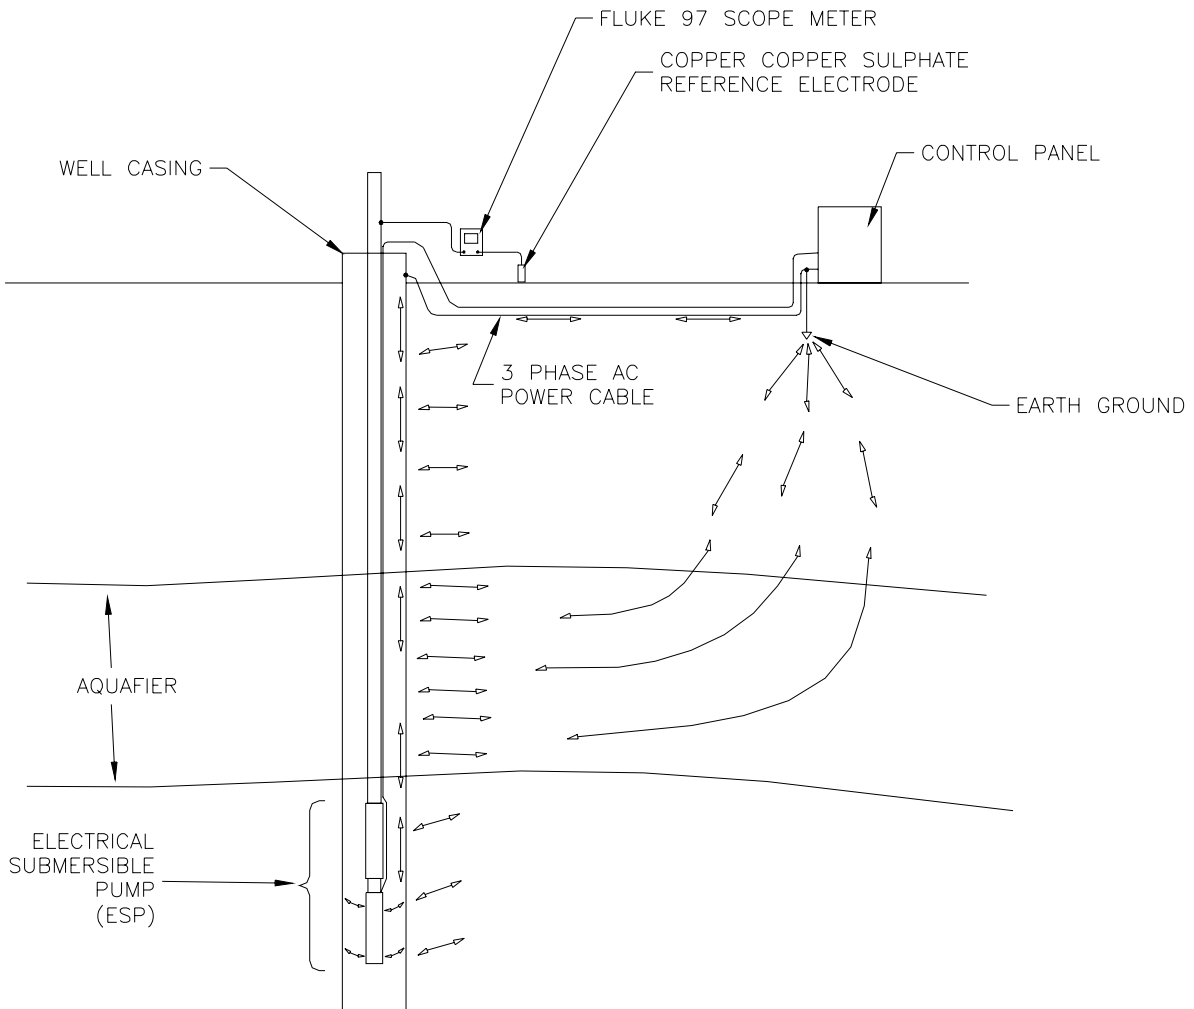
FIGURE 2

It was suspected that the adjacent ESP motors, located at the lower extremities of their casings, were generating stray electrical currents (Figure 2), and that the stray currents, in turn, were effecting the surrounding casings. An investigation was conducted in order to determine what factors, if any were causing the ESP motors to generate stray currents.

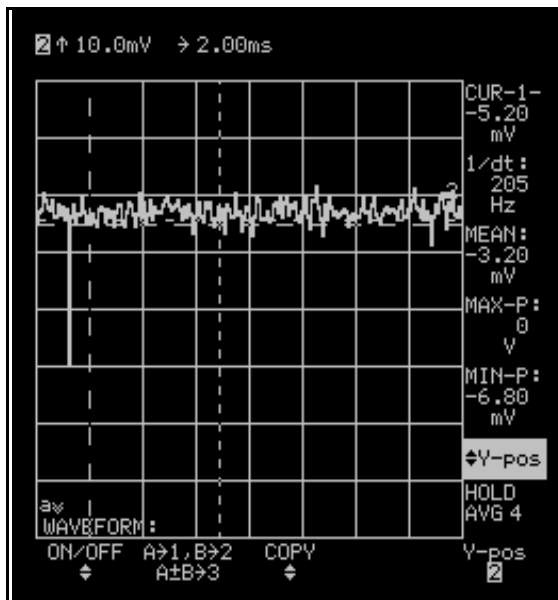
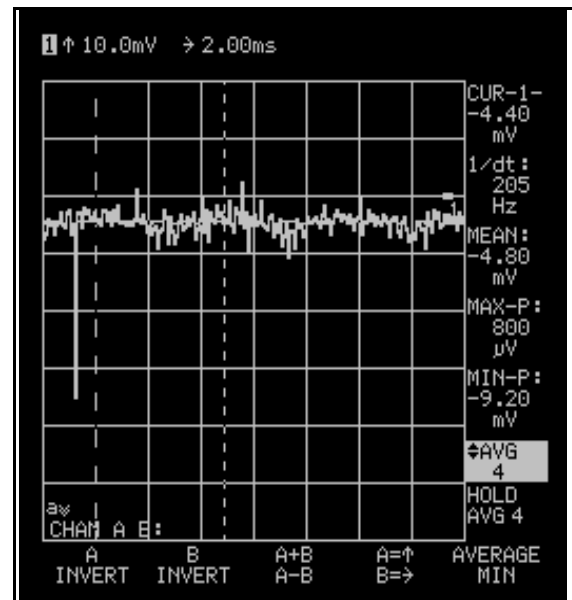
Two current measurements were recorded on a portable oscilloscope, for each ESP tested. One ground current was recorded with the ESP motor turned off and one with the ESP motor operating under normal load. The two upper traces depicted on Figure 3 indicate that there was very little difference in the amount of current flowing on the surface of the ground when the ESP motor No. 116 was turned off or when it was operating at normal load. Essentially the same traces were obtained for ESP motor Nos. 042, 054, 061, 072, 088, 112, and 113. Each of the eight ESP motors depicted on the upper traces of Figure 3 were also measured for phase to ground faults. None of the eight motors exhibited phase to ground faults.

042,054,061,072,088,112,113,116
MOTOR OFF

042,054,061,072,088,112,113,116
MOTOR ON

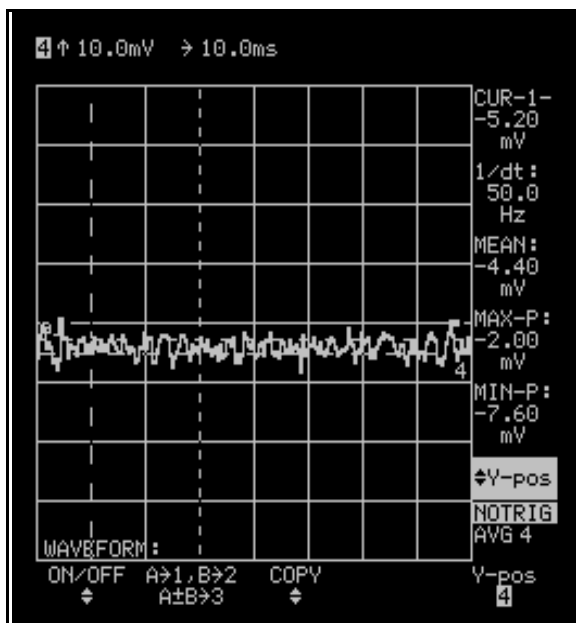
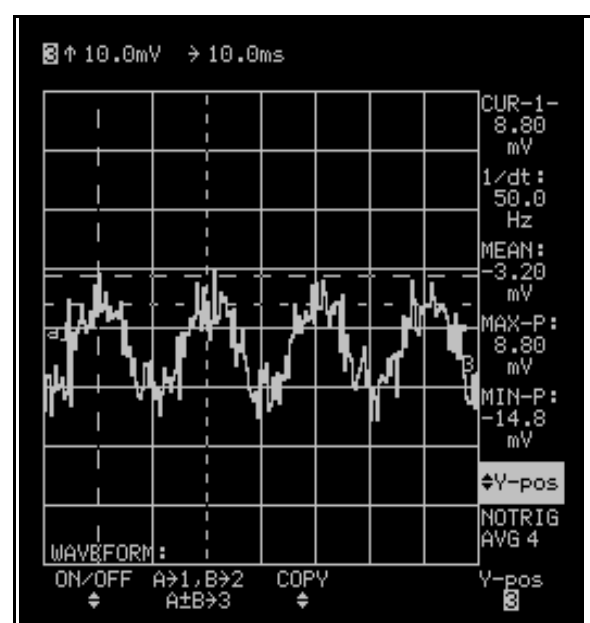
The two lower traces depicted on Figure 3 indicate that there was more than a four fold increase in the magnitude of the AC current flowing at the surface of the soil when ESP motor No. 092 was turned on and operated at normal load. When tested, ESP motor No. 092 was found to have a significant phase to ground fault.

092 MOTOR OFF

092 MOTOR ON

Motors with one power phase shorted to ground will continue to operate and produce oil. However, the benefits of allowing a motor with a phase to ground imbalance to continue to operate, must be evaluated against the substantial cost of repairing or replacing the ESP motor housing and the surrounding well casings.
