**John Bollinger, Farwest Corrosion Control Company, USA,**  
 discusses design considerations in utilising sacrificial  
 magnesium anodes for newly buried pipelines.

# CATHODIC COMPLEXITIES

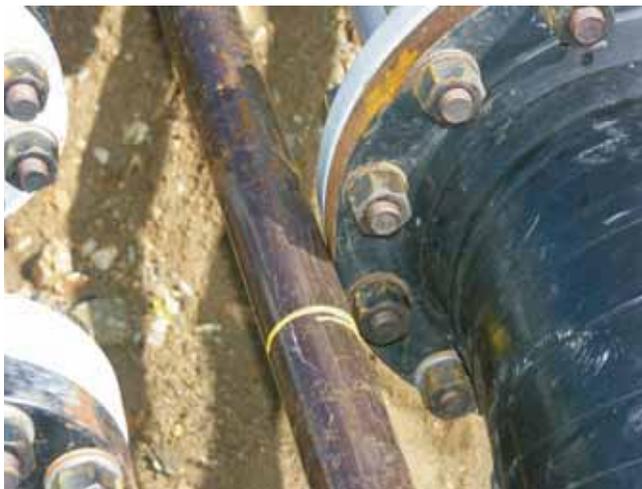
Figure 1. Shorted parallel pipeline.

Any physical contact between a subject pipeline and a foreign structure, in this instance another pipeline, will electrically bond or short the two structures together creating many CP related problems for the operators of both pipelines. Therefore, much care and planning to avoid this issue is critical to isolating the pipeline.

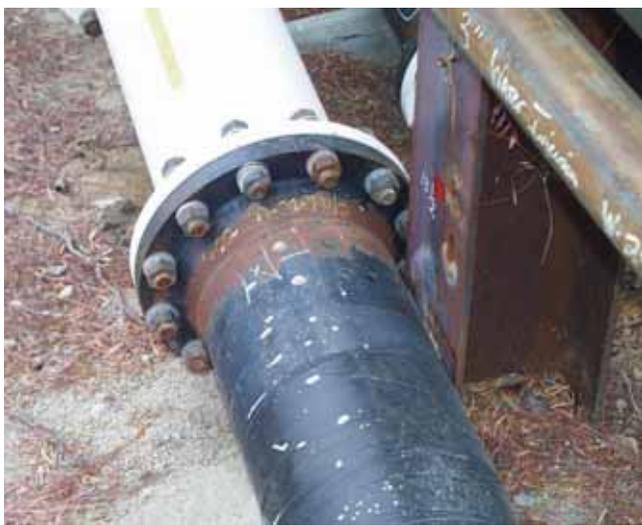
Figure 2. Pipeline electrically shorted to structural steel.

Any compromise to the pipeline's electrical isolation will reduce or nullify the effectiveness of the CP system. When an isolating fitting fails or is bypassed by some parallel metallic circuit (such as a new conduit installation or similar) that touches the isolated section of pipeline, the CP current requirement will increase, which in turn will shorten anode life and/or minimise the CP system's ability to protect the pipeline.

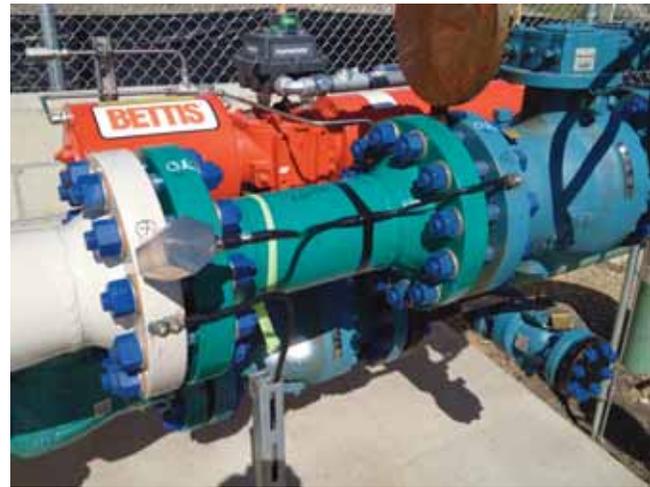
Figure 3. Over voltage protector across a double isolated, internally lined pipeline spool.

One proven method to reduce the induced voltages on the pipeline is to install numerous magnesium anodes or other grounding devices to serve as 'ground rods'. Besides the improved grounding ability, the anodes can provide needed CP current. Additionally, there are also electronic over voltage protection devices that can be installed on the pipeline to offset these high voltage events. In extreme cases, dedicated low resistance grounding electrodes with associated DC decoupling equipment may be required.

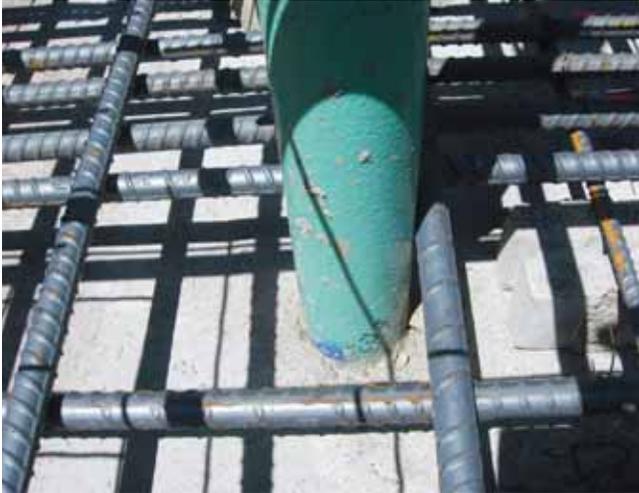
Figure 4. Pipeline electrically shorted to rebar.

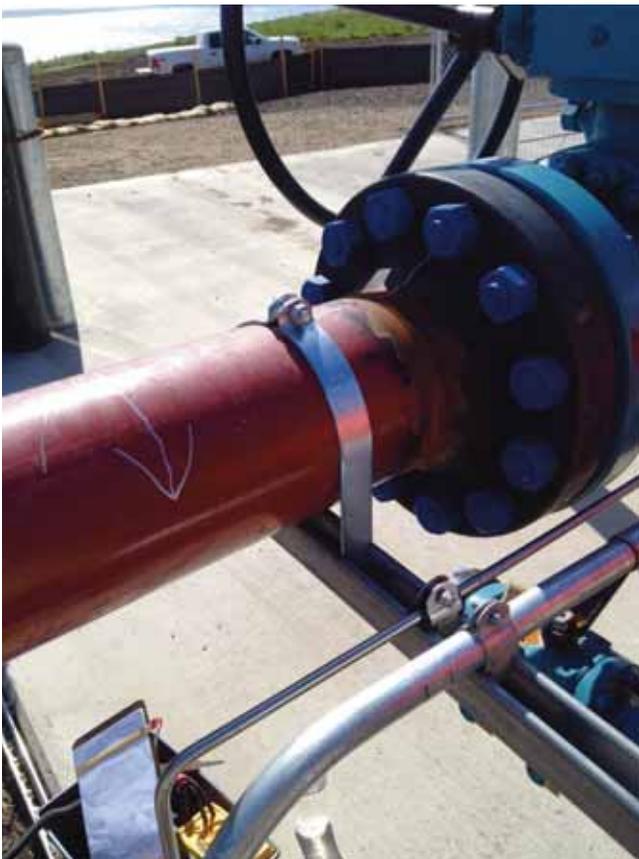
Figure 5. Electrical conduit shorted to protected pipeline.
