CASE HISTORIES

# Causes of Flange Isolation Gasket, Sleeve, and Washer Failure

JOHN T. KELDSEN, *Pipeline Seal and Insulator, Inc., Houston, Texas*

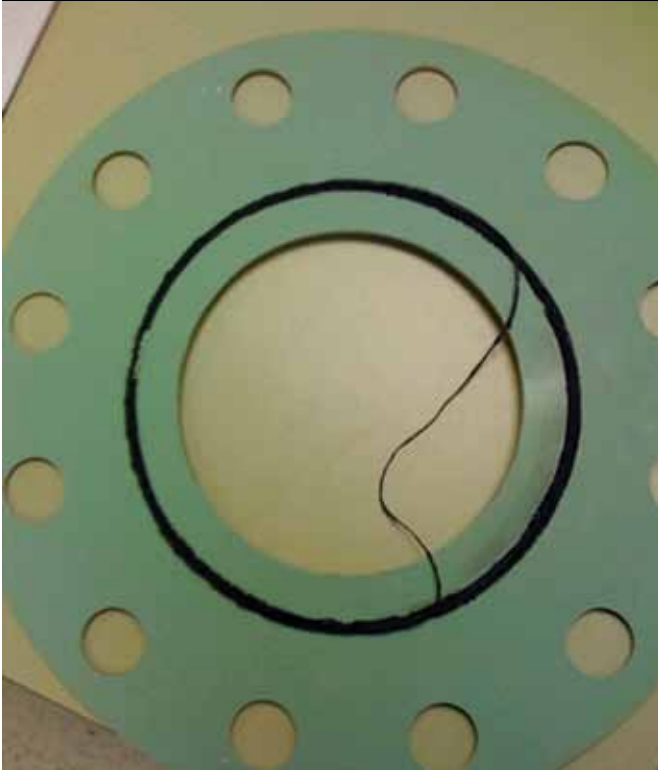
FIGURE 1

The gasket in Figure 1 appears to have a seamless, molded sealing element with inconsistent quality control of the volume-to-void relationship. The groove depth for the sealing element also exhibits unacceptable variances.

Leaking oil company gasket.

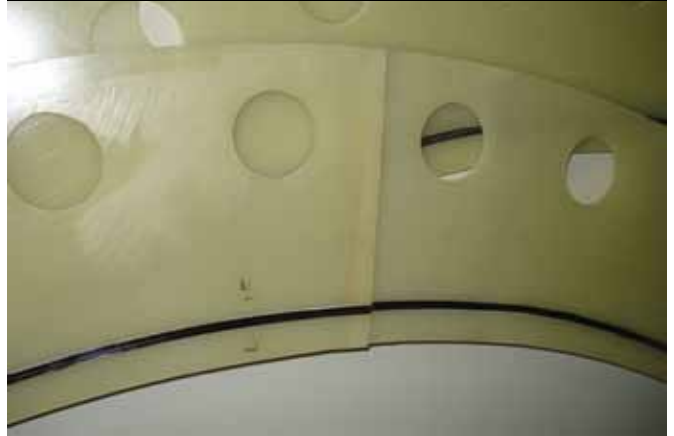
FIGURE 2

The retainer material for the gasket in Figure 2, an alternative to the specified gasket, was not made in a sheet size large enough for an 84-in (2-m) pipe, so the manufacturer spliced it together. The high visibility of the splice indicates that it was not well made; this should have been detected during field inspection prior to installation. Personnel responsible for installing flange isolation kits are not always adequately trained in component inspection criteria, however. The fabrication shop producing the alternative gaskets could not get them to pass hydrostatic pressure testing, but the originally specified gaskets installed on the same flanges worked without exception.

The gasket for a water project failed the initial hydrotest.

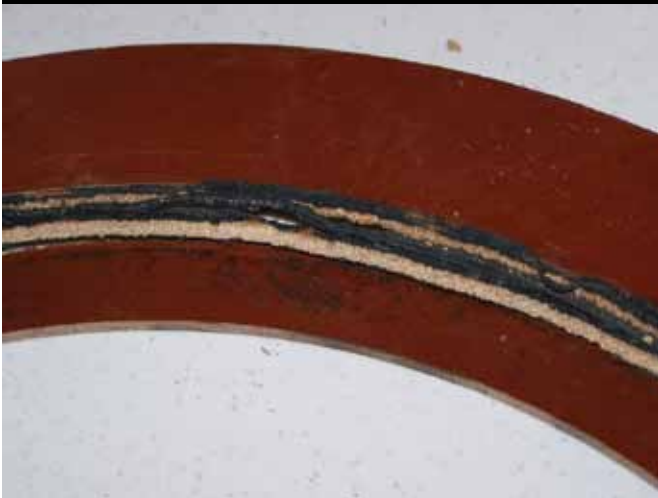
FIGURE 3

Figure 3 illustrates a gasket that failed upon hydrotest. The quality of the laminate, sealing element, and groove dimensions are all questionable. The user successfully replaced all such gaskets with the specified seals.

A gasket for a natural gas project.

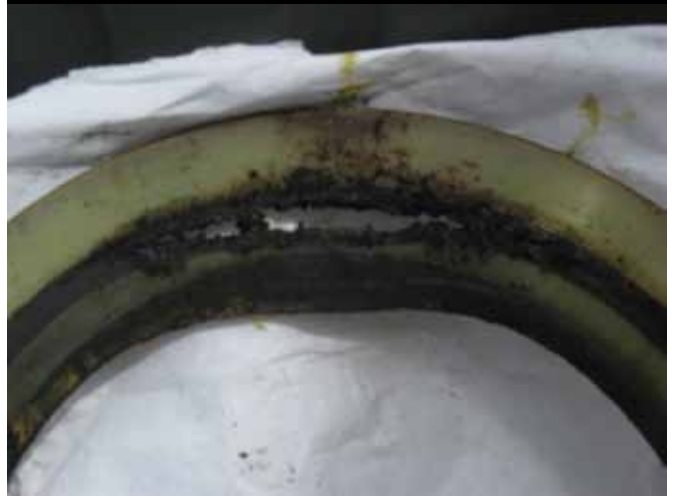
FIGURE 4

The gasket in Figure 4 appears to have split or cracked at the sealing element location from improper dimensioning or durometer testing of the elastomer. Al-

A gasket from a treated water dump.

though the original specification is absent, the gasket obviously was not made properly for the intended application.

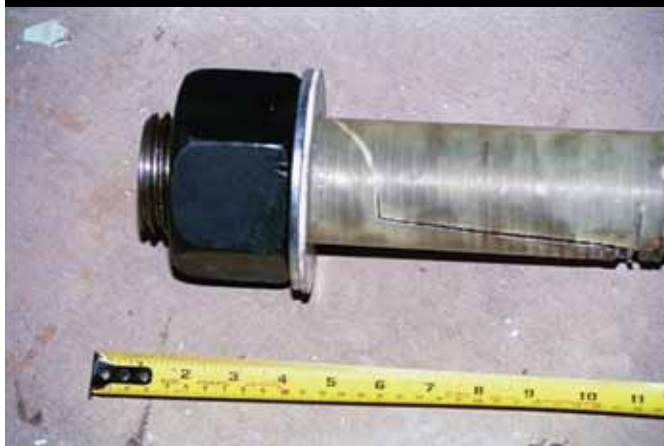
FIGURE 5

Bolt sleeve failure from shear stresses.

In Figure 5, the 45-degree failure angle with respect to the bolt’s axis indicates that the sleeve failed in shear. The contractor ordered G-10 isolation washers and sleeves from one supplier and the steel washers from another. Normally, the isolation and steel washers are supplied as part of a kit. In this case, the steel washers had a slightly smaller inside diameter (ID) than the G-10 washers, so there was

no clearance between the steel washers and the sleeve. As the nuts were tightened, the steel washers grabbed the sleeves and twisted them. To avoid this problem, both the steel and isolation washers must be manufactured to precise dimensions with matching ID and outside diameters (OD) for uniform loading and to allow the sleeve material to fit within the ID of both washers.

Specifications for flange isolation kit sleeve material frequently call for the sleeve to be “full length,” an undefined measure for which there is no known industry standard. A better specification would require the minimum standard length of the sleeve to extend at least halfway into the back-up steel washers.

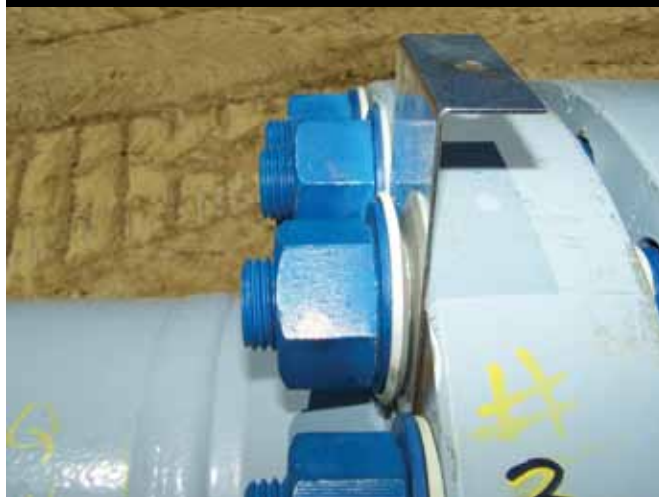
FIGURE 6

Over-compressed white isolation washer.

The white isolation washer in Figure 6 was squashed from the compressive load of the blue steel washer. In this case, the problem was caused by using the wrong washer material for the loads being applied and the dimensional variance between the steel and isolation washers. It also can be caused by overloading the compressive strength of the washer.
